Automatic Sprinklers: Sprinklers Beneath Mezzanines

No. FP-2010-40 October 5, 2010

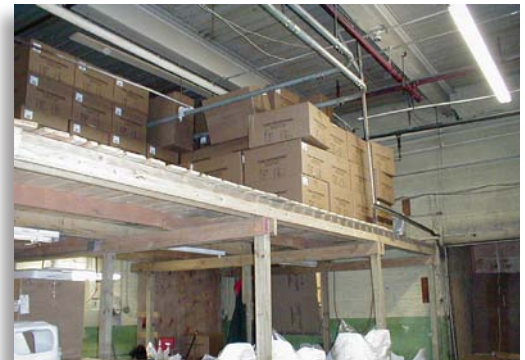
This "add on" mezzanine increases storage capacity, but requires automatic sprinkler protection beneath it. Photo courtesy of Martin M. King, West Allis, WI.

Today's photo illustrates a common problem found on inspections: a sprinklered storage space with high ceilings where someone has increased storage capacity by erecting a combustible mezzanine.

The construction has created a "continuous" obstruction that would interrupt water flow from the ceiling sprinklers, preventing it from reaching the products stored on the floor. The National Fire Protection Association (NFPA) 13, *Standard for the Installation of Sprinkler Systems*, requires that additional sprinklers be installed beneath obstructions that interrupt the water discharge in a horizontal plane more than 18 in (457 mm) below the sprinkler deflector when the obstruction prevents adequate coverage.

A closer look at this picture reveals another issue that may be a concern for the fire inspector: plastic materials stored beneath the mezzanine. While the quantity in the photograph may not be sufficient to affect the sprinkler system hazard class, a complete analysis of the storage configuration should be considered. Coffee Break Trainings 2008-25 through 2008-29 discussed the impact of plastics on fire protection system design.
